**What The Coastal Community Association Has Done With This Effort:** As a result of numerous questions and conflicting opinions about the St Joseph Peninsula beach nourishment and breakwaters project, the CCA undertook an effort to gain the facts that we hope can help answer questions, rebut any incorrect rumors, and generally raise awareness. To accomplish that we did research based on the readily available sources like those made available during the public comment period and the bidding process. After compiling that information, we met with the County and confirmed and further bolstered our understanding. What follows below is a summary of that effort

### **What Is The Scope Of The Current Project?**

# PERMIT SKETCHES

BEACH FILL SECTIONS B-B'  
 ST. JOSEPH PENINSULA COASTAL STRUCTURES  
 1000 South G. Corbett, St. Joseph, MO 64506  
 202-210-9011  
 6

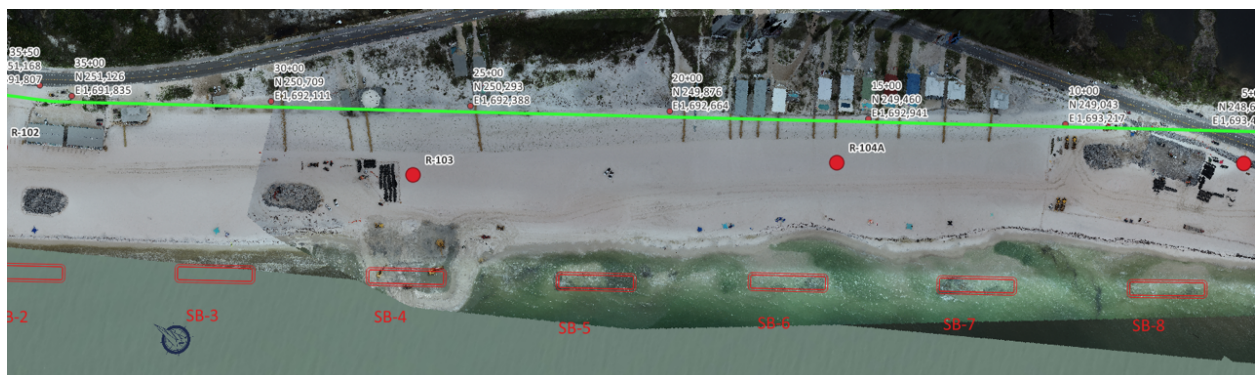
We were also given an aerial shot of the construction of SB-4 that shows all of the breakwaters are in water (likely at high tide). Notice the wrack line of debris on the beach. Breakwaters 5, 6, 7 and 8 are complete, but currently covered in sand. See below for more detail on that.
